Manhole Inspection Summary

Manhole # S41QQ_022MH

Location Address: **2513 AISQUITH AVE**

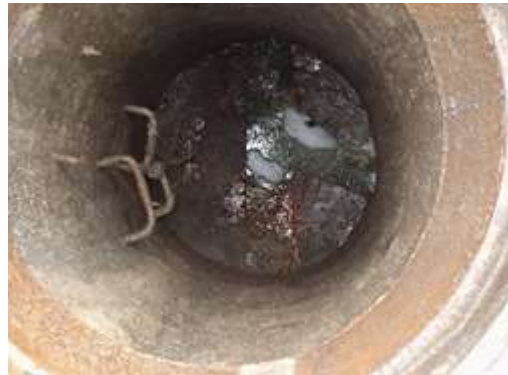
Top View

Corroded and missing steps. Evidence of surcharge - Bench debris. Channel debris.

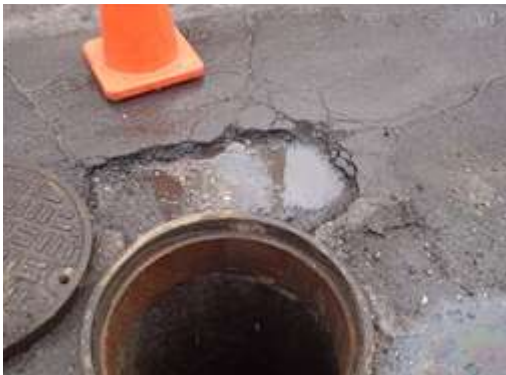
Hole near manhole

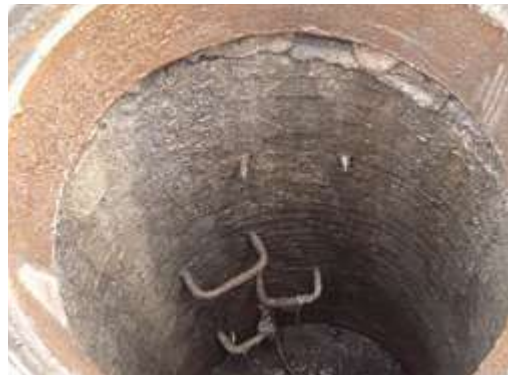
Defect

Frame leaks. Adjustment deterioration and infiltration.

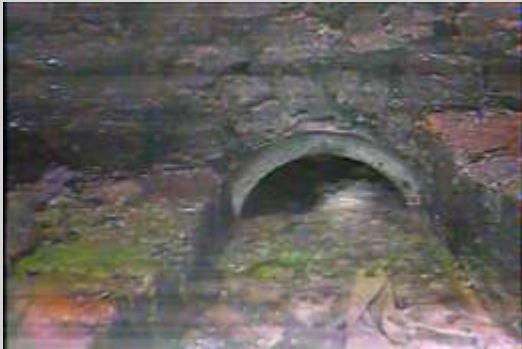
8 in. Circular Gravity Sewer Pipe Out @ 12 O'Clock

Barrel deterioration and infiltration. Channel debris.

Deposits: ☐ None ☒ **Mud** ☐ Sludge ☒ **Debris** ☐ Grease

Silt Depth: **4** (in.) Deposits Extent: **Medium**

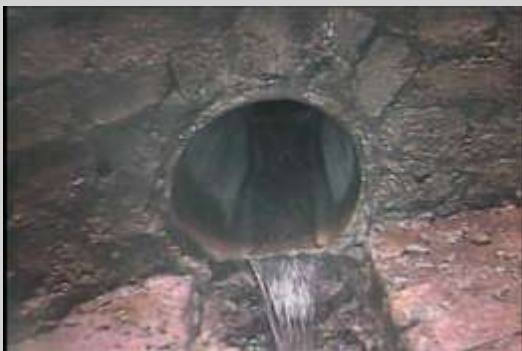
8 in. Circular Gravity Sewer Pipe In @ 3 O'Clock

Barrel deterioration and infiltration.

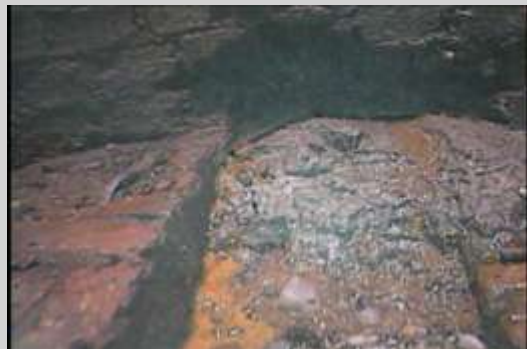
Pipe In @ 6 O'Clock

Barrel deterioration and infiltration. Channel debris.
